GARDNER CREEK DAM

NDS ID NO. PA-00575

PHASE I INSPECTION REPORT

NATIONAL DAM INSPECTION PROGRAM

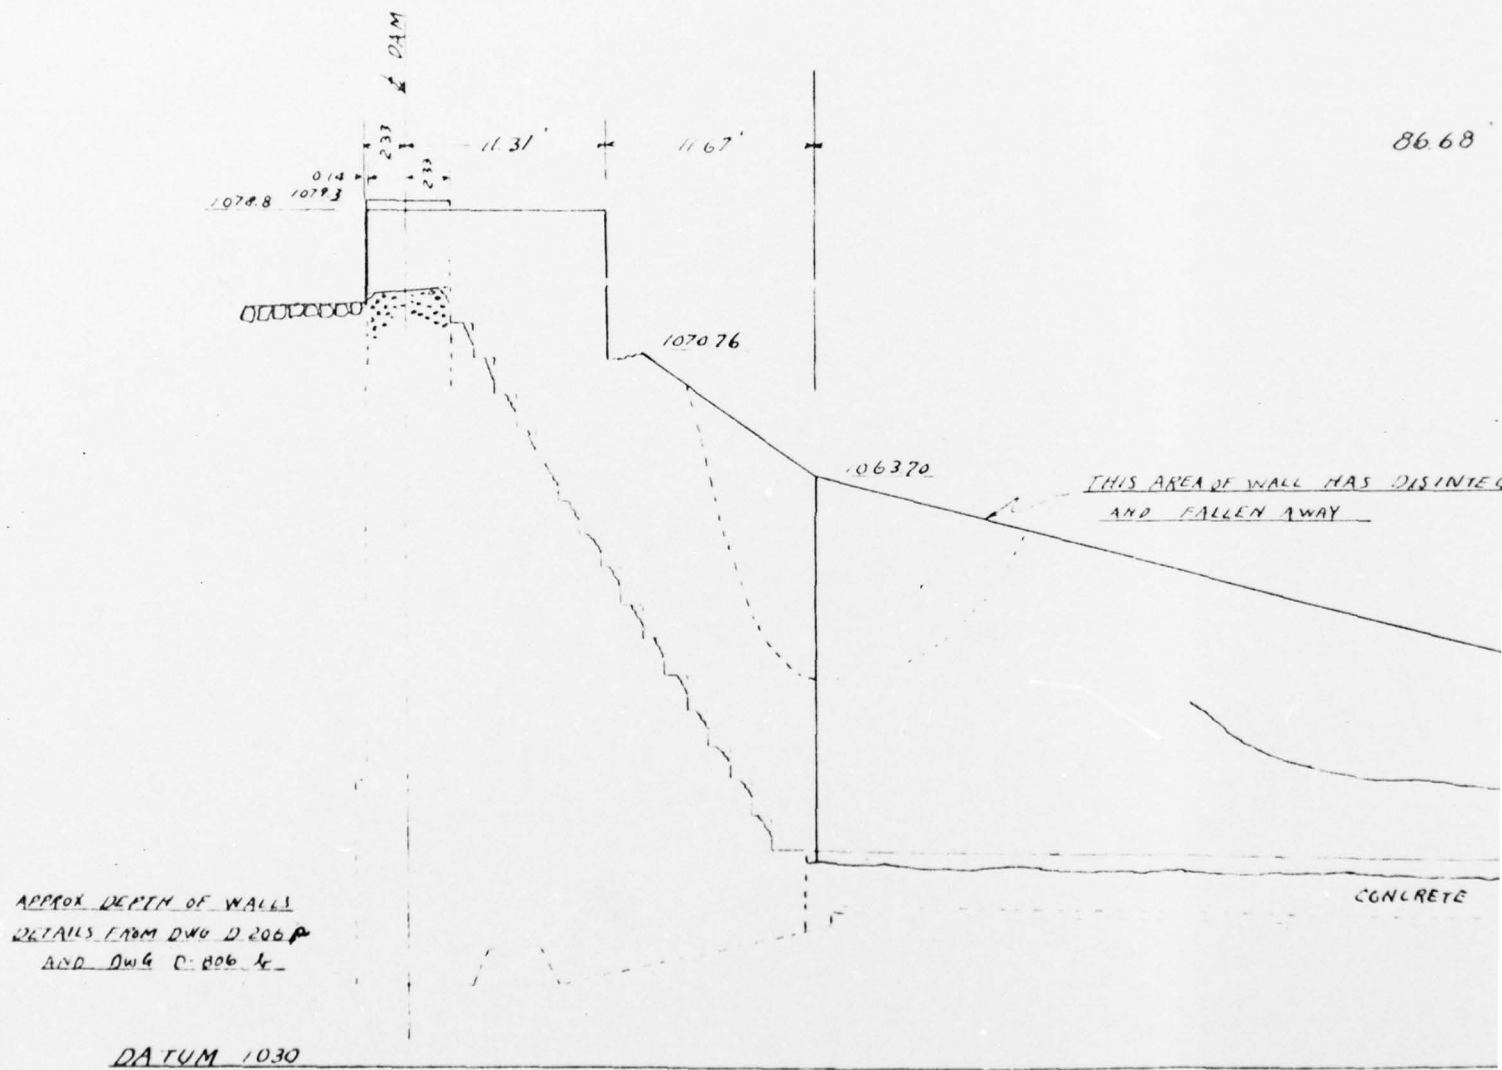
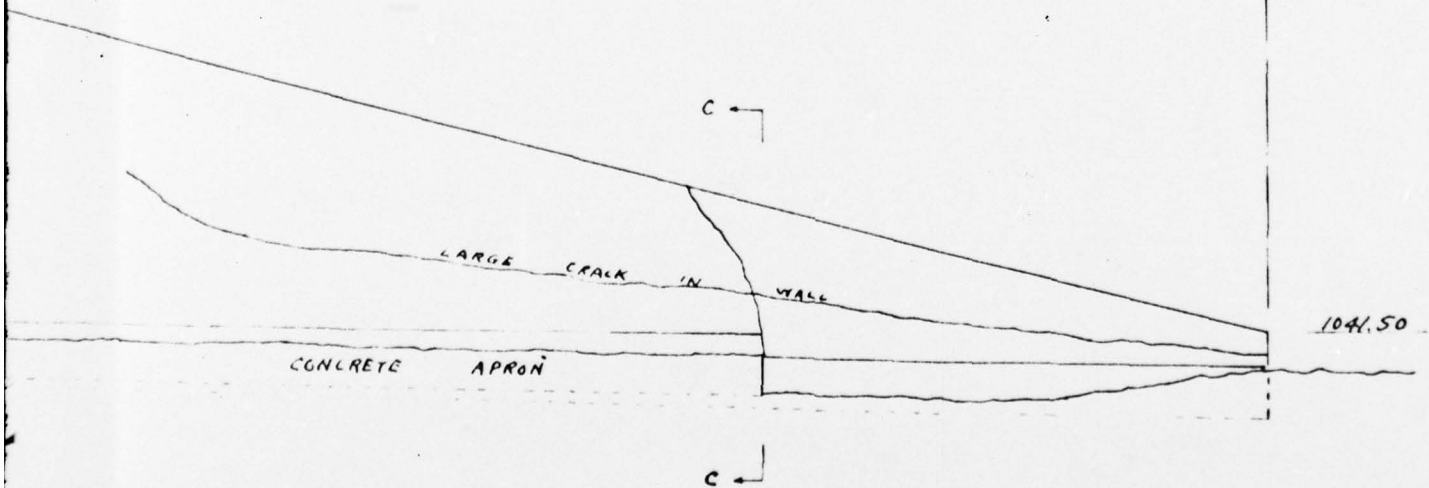
ELEVATION OF SOUTH WING WALL
SECTION B-B
SCALE 1" = 10'

THIS AREA OF WALL HAS DISINTEGRATED
AND FALLEN AWAY

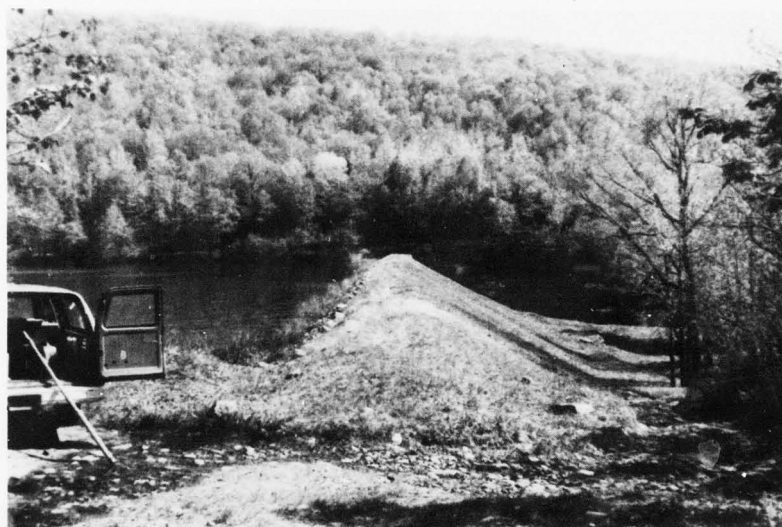
(3) The downstream slope of the embankment had a uniform slope and was adequately maintained. (Photographs A and B). The vegetation consisted of a light growth of weeds and very small shrubs. The type and extent of the vegetation indicated a rather fragile environment. There appeared to be very little topsoil available to support development of sod. Vegetation on the downstream slope had been cut recently. A path was worn or excavated on the downstream slope near the right abutment to a maximum depth of 2 feet. One hole caused by a burrowing animal was located near the center of the dam about 10 feet above the toe. Signs of recent burrowing were observed.

A. Embankment Looking from
Right Abutment

- (3) Repair bare path on downstream slope of embankment.

- (4) Fill hole on downstream slope of embankment caused by burrowing animal.

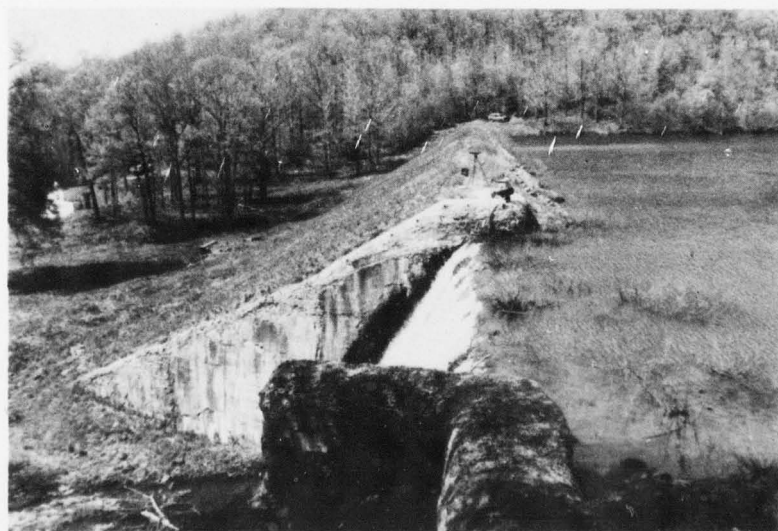
B. Spillway and Embankment Looking from
Left Abutment

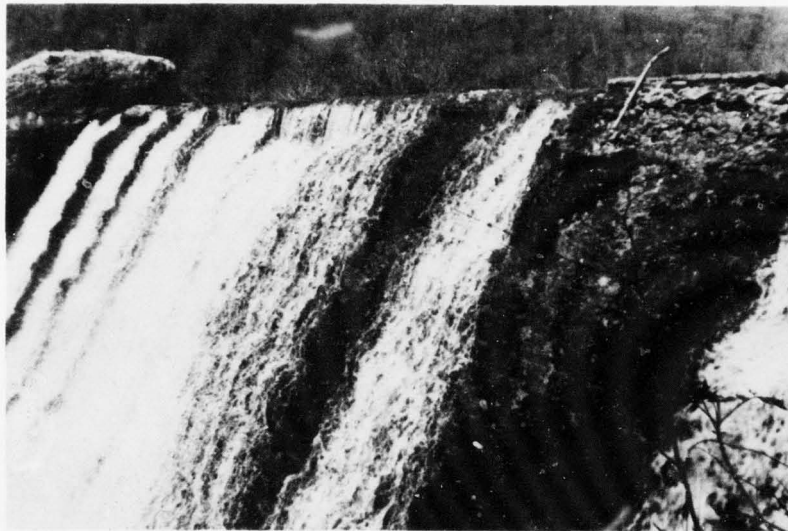
(2) Flow over the spillway crest and over the stepped downstream face of the spillway was not uniform due to disintegration of the concrete (Photographs C and D). Coarse aggregate was exposed over most of the area, and the disintegration had progressed to an estimated depth of 6 inches at some locations. The steps on the downstream face were badly eroded and, in some cases, missing. The downstream face of spillway could not be inspected for leakage or cracking because of the amount of water flowing over it.

C. Crest and Downstream Face of Spillway

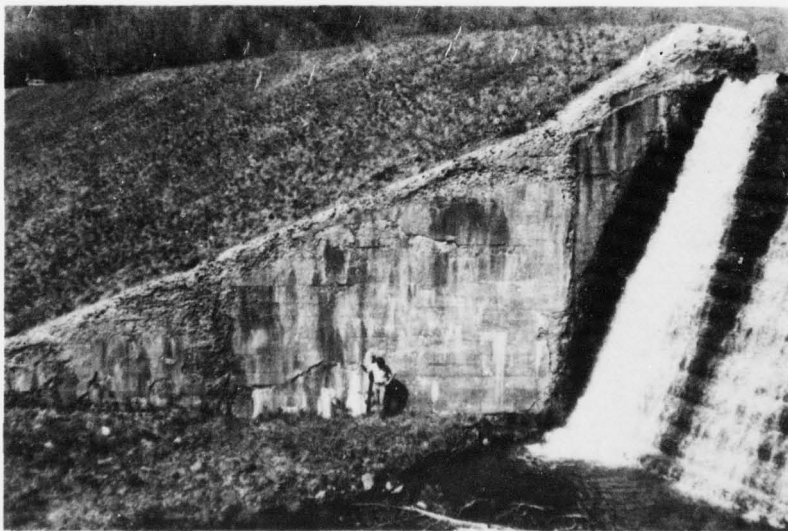
(4) The right spillway wall had very severe scaling over about 30 percent of its exposed face (Photograph D). The average depth of scaling was about 1 inch. A vertical crack was located near the downstream end of the wall. The crack is weathered, but no differential movement was observed.

D. Right Spillway Wall

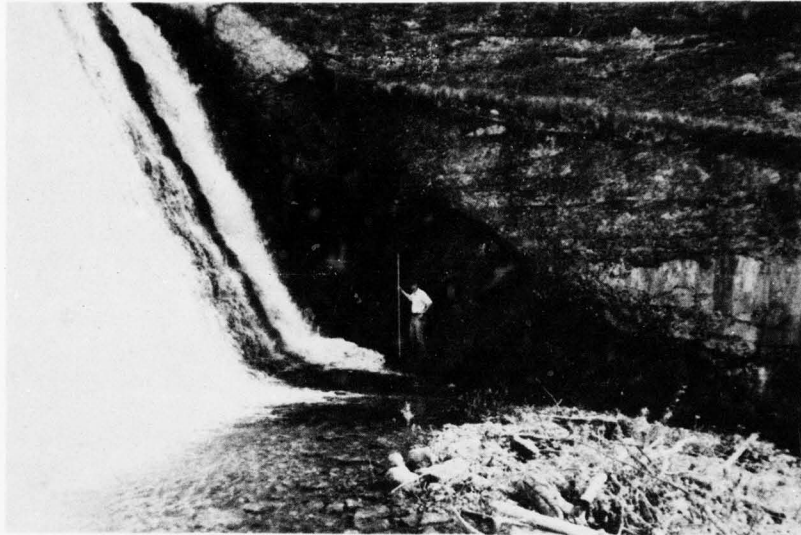
(5) The left spillway wall had severe disintegration over about 80 percent of its exposed face (Photographs E and F). The worst area was a about mid-height near the toe of the spillway (Photograph E). At that location, the estimated depth of disintegration was 2 feet. An average depth of disintegration for the wall could not be determined. A 70-foot long crack, predominantly horizontal and located about 4 feet above the channel bottom, begins near the downstream end of the wall and extends upstream into the area of most severe disintegration (Photographs E and F). The portion of the wall above the crack was overhanging the lower portion by an average of 0.35 foot.

the Owner indicate an average movement at that time of 0.16 foot. The present average displacement is 0.35 foot. This increase in displacement, coupled with areas of disintegration to depths of about 2 feet, indicates a potentially serious condition. If this wall failed, a slide of the adjacent hillside would probably also occur. It could not be determined from the visual inspection whether a failure of the wall would seriously endanger the dam and the spillway. The effects of failure would depend on extent of failure, amount of sliding of the hillside, and pool level at time of failure. It is sufficient to say that every effort should be made to avoid a failure of the wall.

E. Disintegration, Large Crack, and Displacement of Spillway Left Wall

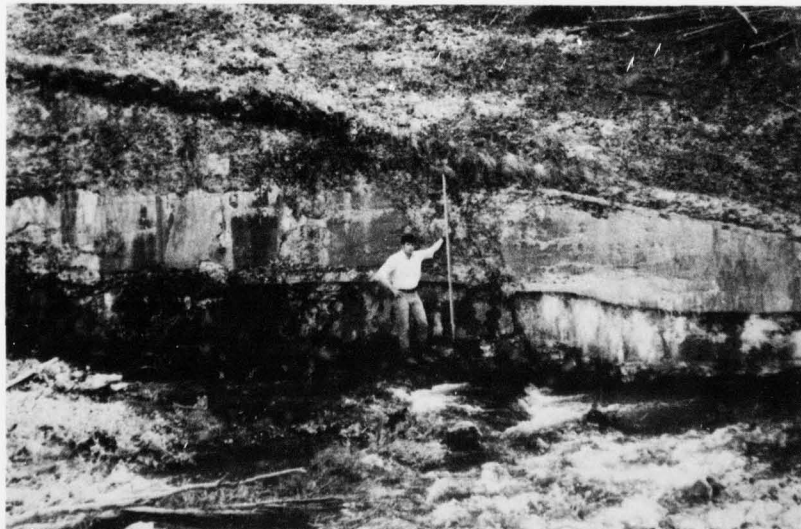
F. Continuation of Above Photo showing Cracking and Displacement of Left Spillway Wall

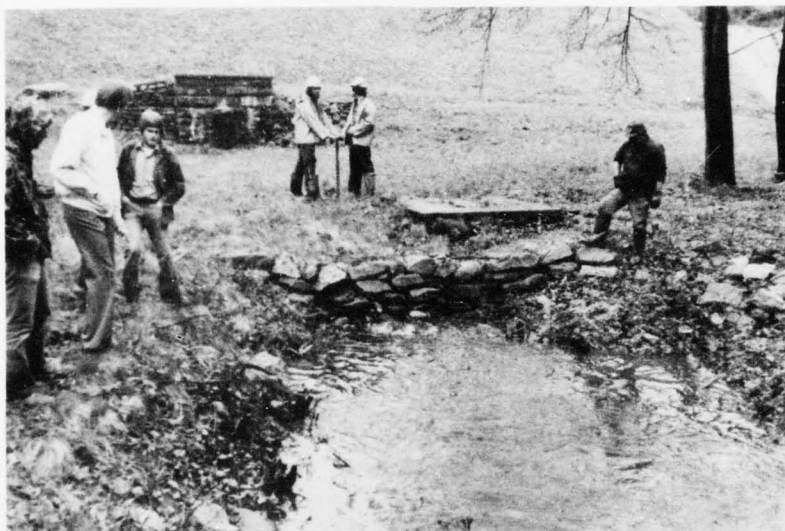
4.5 Evaluation. Except for not opening the blowoff valve on a regular basis, the operational procedure appears to be satisfactory. Infrequent operation of the blowoff could affect its functioning satisfactorily during emergency conditions. The procedures used by the Owner for inspecting the dam are adequate, but repairs have not been made. In general, the warning system is adequate, but it should be more detailed.

G. Operation of the 16-Inch Diameter Blowoff

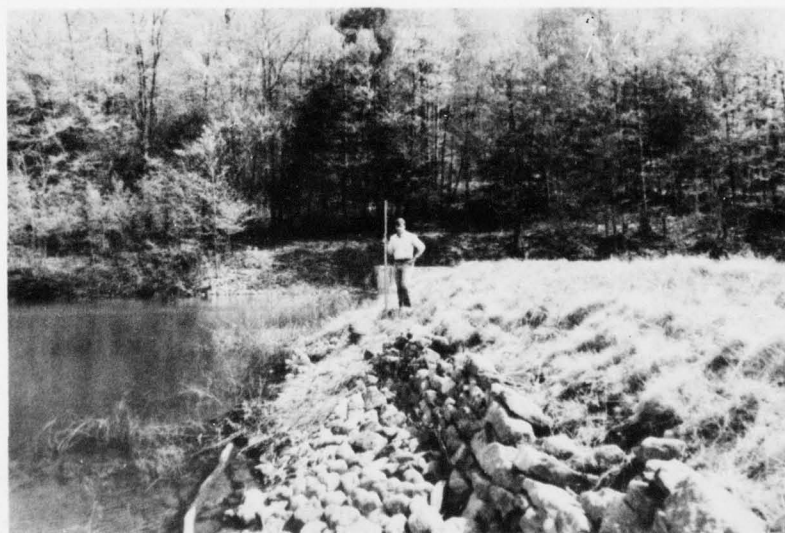
(2) The light brush growing on the upstream slope of the embankment is undesirable. The 30-foot reach adjacent to the spillway where the riprap is missing could easily be eroded during large flood flows or by wave action.

H. Upstream Embankment Surface on Right Side of Spillway showing Missing Riprap Material

- (2) Replace missing riprap near spillway.

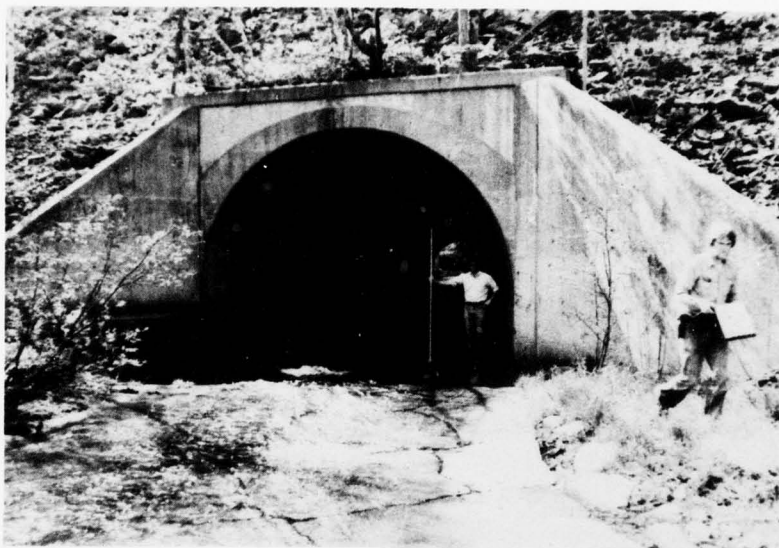
conduit through the embankment is a concrete horseshoe type with a width of 18.6 feet and a height of 13.0 feet (Photograph I). Just downstream from the Turnpike embankment is the railroad embankment. It is about 25 feet high and about 100 feet wide at the base. The material in the railroad embankment fill appeared to be cinders. The conduit through the railroad embankment is a masonry horseshoe type with a width of 9.8 feet and a height of 12 feet (Photograph J). If Gardner Creek Dam failed, the two downstream embankments could decrease or increase the hazard to human life or property. If the embankments did not fail as a result of a failure of Gardner Creek Dam, the hazard to human life and property would decrease. If the embankments did fail as a result of a failure of Gardner Creek Dam, the hazard to human life and property could increase. The mechanics of the interaction between the failure of Gardner Creek Dam and the two downstream embankments are complex and beyond the scope of this study. Therefore, it cannot be assumed that the hazard to human life and property resulting from a failure of Gardner Creek Dam would be reduced by the existence of the two downstream embankments. Consequently, the downstream conditions indicate that a high hazard classification is warranted for Gardner Creek Dam.

I. Outlet Channel Conduit under the
Pennsylvania Turnpike, 0.4 Mile Downstream from Dam.
Driving through Conduit is Access Route to Dam.

(9) Develop an alternate access route to the dam that would be accessible under all conditions.

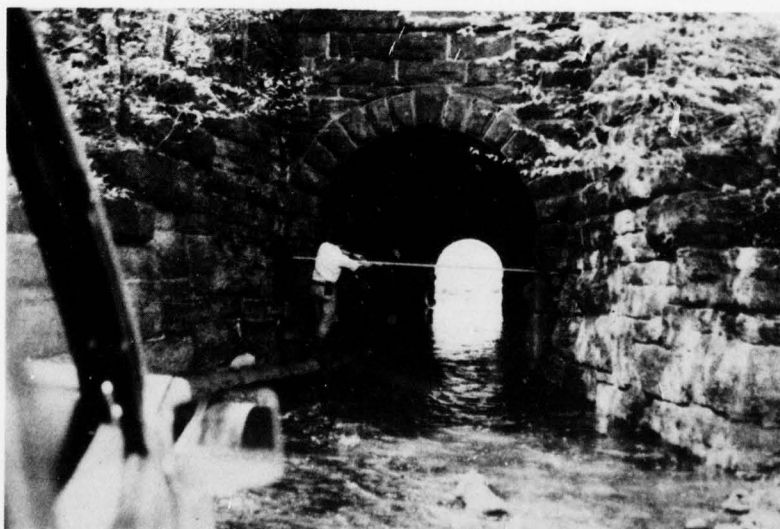
J. Outlet Channel Conduit under
Lehigh Valley Railroad
located immediately downstream of
the Pennsylvania Turnpike Conduit
